COUNTRY USSR (Ukrainian SSR) SUBJECT 1. Port of Odessa 2. Naval and Merchant Ships in Odessa	REPORT [REDACTED] DATE DISTR. 7 March 1957 NO. PAGES 1 REQUIREMENT NO. [REDACTED] REFERENCES [REDACTED]
--	--

Eleven reports on the port of Odessa

SUBJECT: O d e s s a

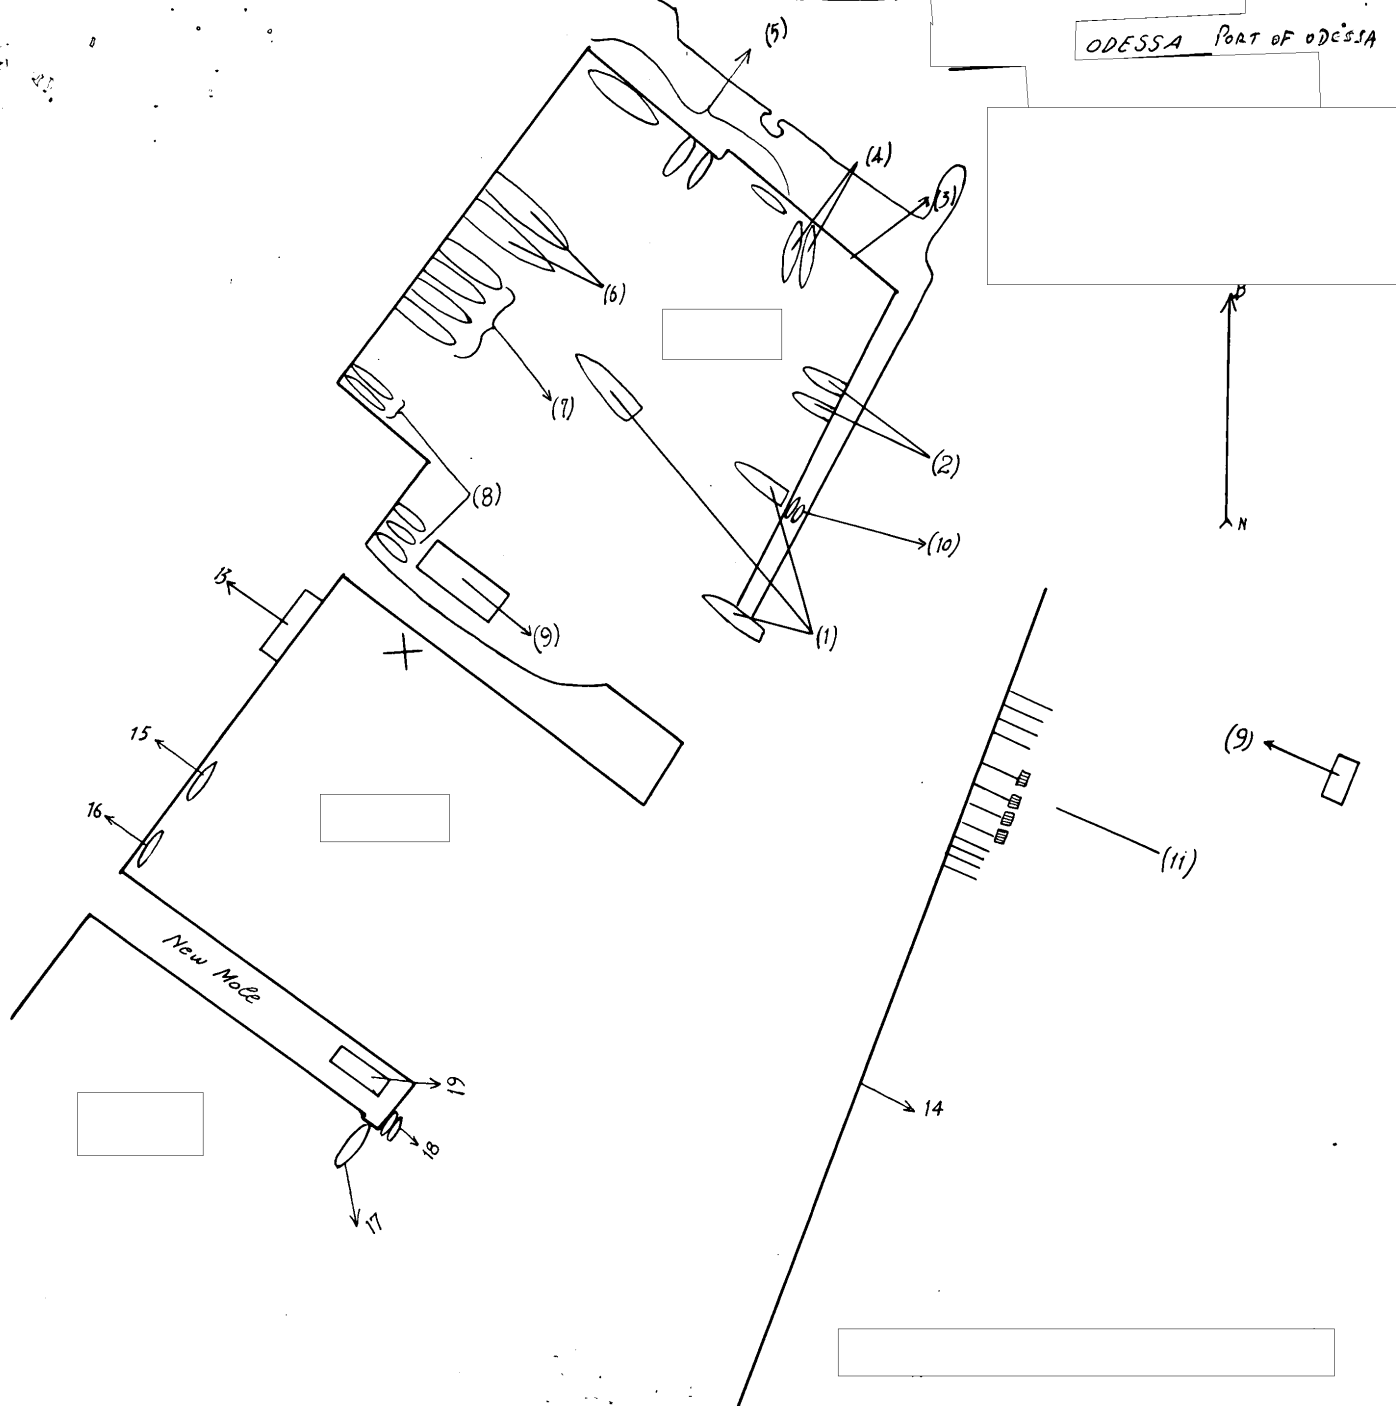
ODESSA PORT OF ODESSA

I. ORGANIZATION (See Attached Drawing)

14. Protective breakwater of harbor.-

1. Three patrol ships. In turrets at bow and stern, these bore two guns separated from each other.-

6. Two destroyers, of which only part of the bridge and an inclining funnel could be seen.

11. Thin poles, approximately 4 meters tall, some of which bore small netted frameworks, were sighted being either on the breakwater or on floating targets behind it. Due to the long distance, could not ascertain their use.-

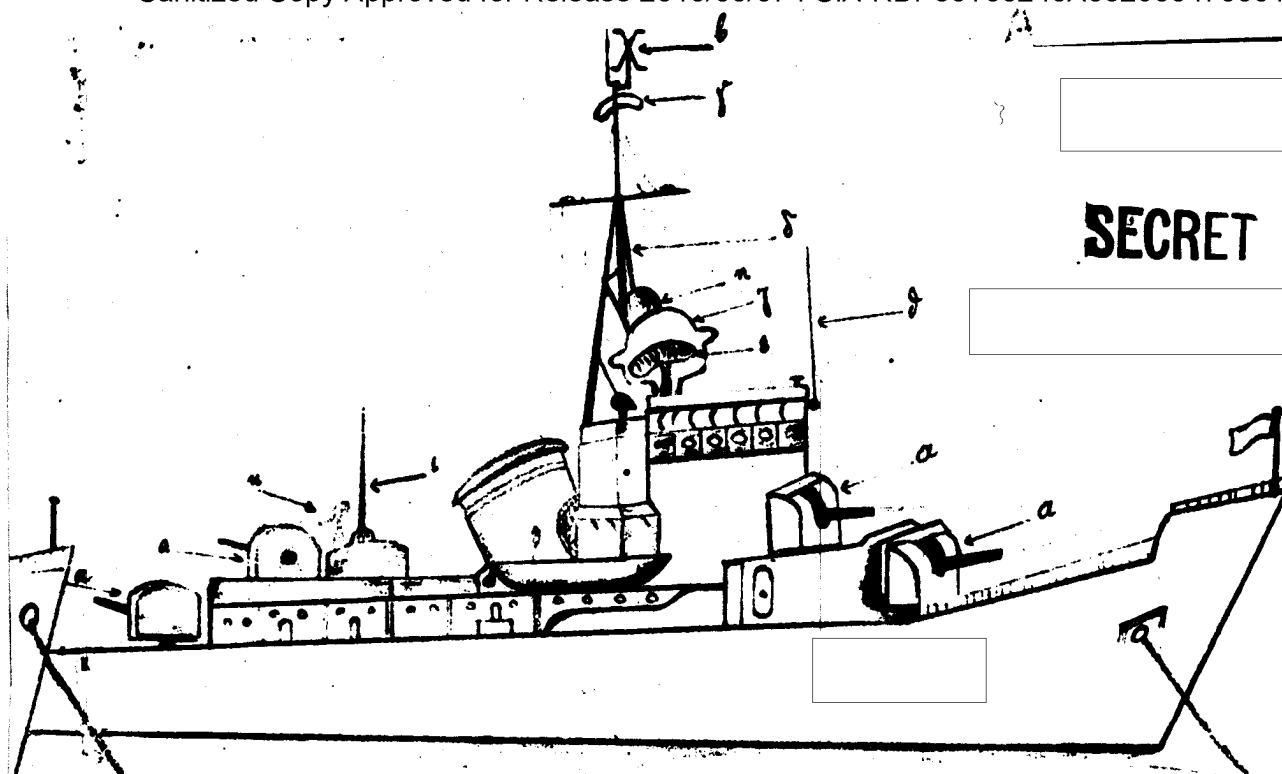
EXPLANATORY NOTES ABOUT THE PLAN

- a) Four guns, of about 4 inches, also used as anti-aircraft guns, in four turrets.
- b) Radar, probably for aircraft.
- γ) Surface radar with solid antenna.
- δ) Three-legged mast.
- ε) Artillery radar with solid antenna.
- ζ) Direction finder.
- η) Unknown object, most probably a radar antenna.
- θ) Antenna of the destroyer, similar to the antennas of ~~two~~ destroyers ~~from~~ from the U.S.A.
- ι) Mast at the bow that is plain.
- μ) Probable position of Radar for the guns that are at the ^{stern}~~bow~~; it could not be seen clearly.

- Steep and high bow.
- Funnel with large declension towards the bow; it was not streamlined.
- Large square-shaped bridge; there was also seen an open top-bridge.
- No torpedo-tubes were observed, nor any light anti-aircraft armament.
- They have depth-charges at the bow.
- the construction in general discloses that they have a good speed.

(At the end of this report ~~is~~ a plan of this type of a destroyer together with explanatory notes and its general characteristics).

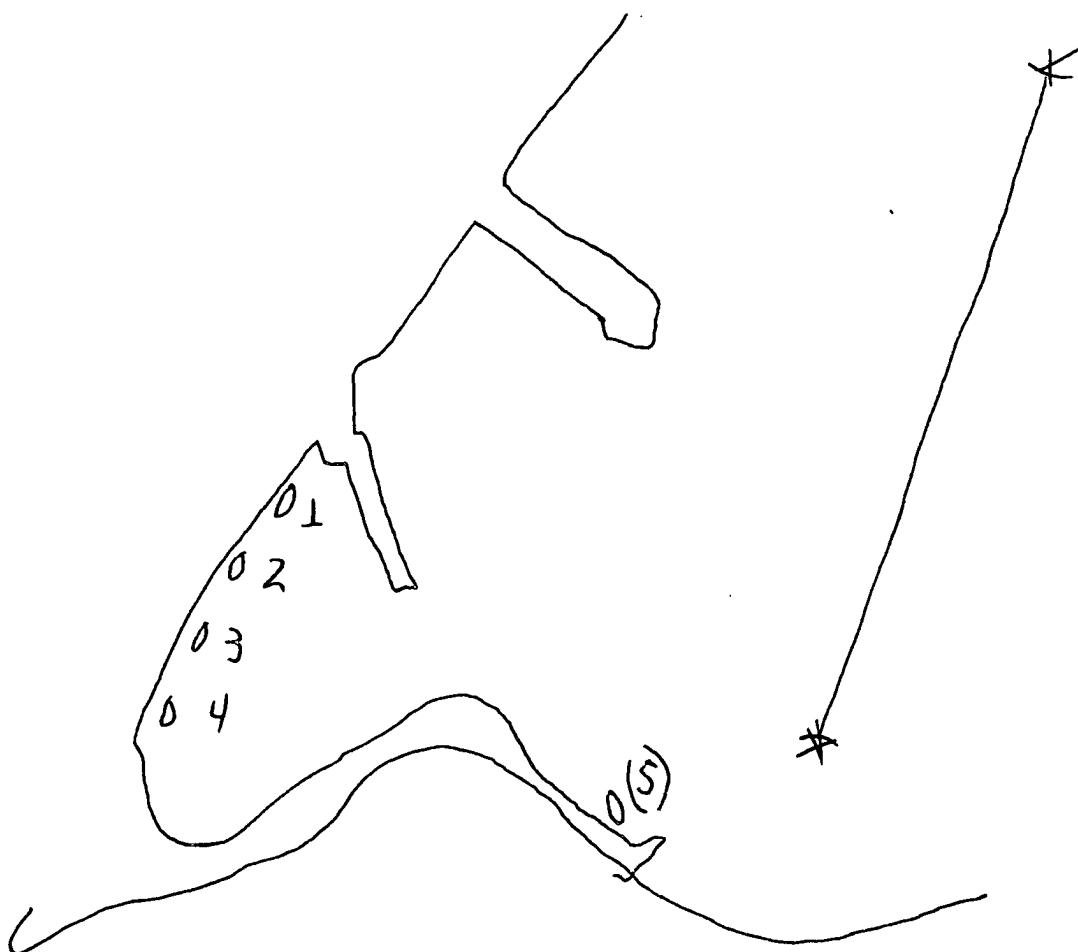
No.1 Position of [redacted] ship.-

No.2 Position of an approx. 14,000 ton

No.3 Position of a small [redacted] vessel [redacted]

No.4 Position of s/s [redacted]

No.5 Position of the tanker 'Talin', about 26,000 tons, undergoing repairs.

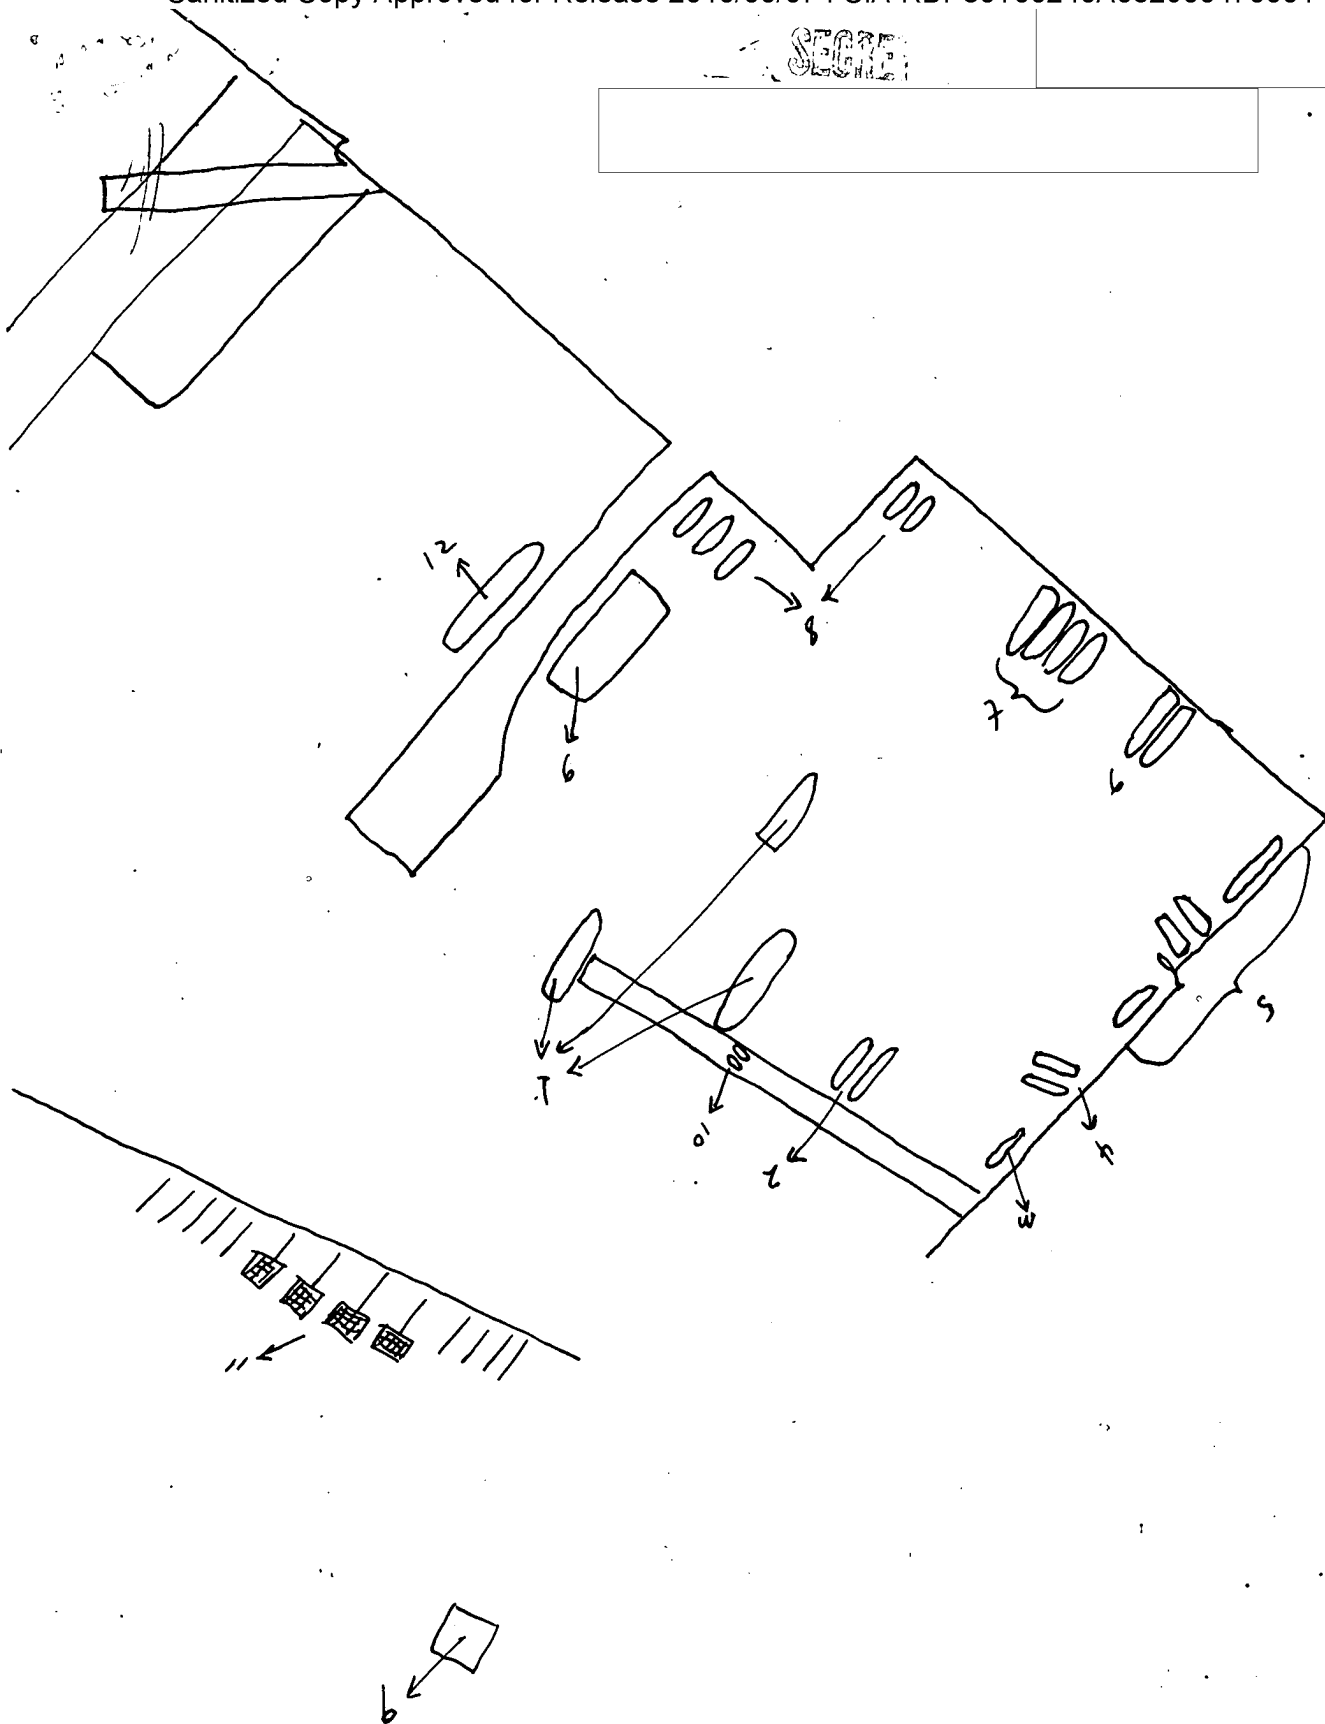
F.- The following were observed in the space reserved in the harbor for the Navy ships to anchor (see drawing).-

1. Three patrol ships bearing four guns each - two on each side, prow and stern - The guns were separated from each other and were placed in little towers.

11. Many poles were observed on the breakwater, four of which bore a net-like thing on their tops (see drawing).

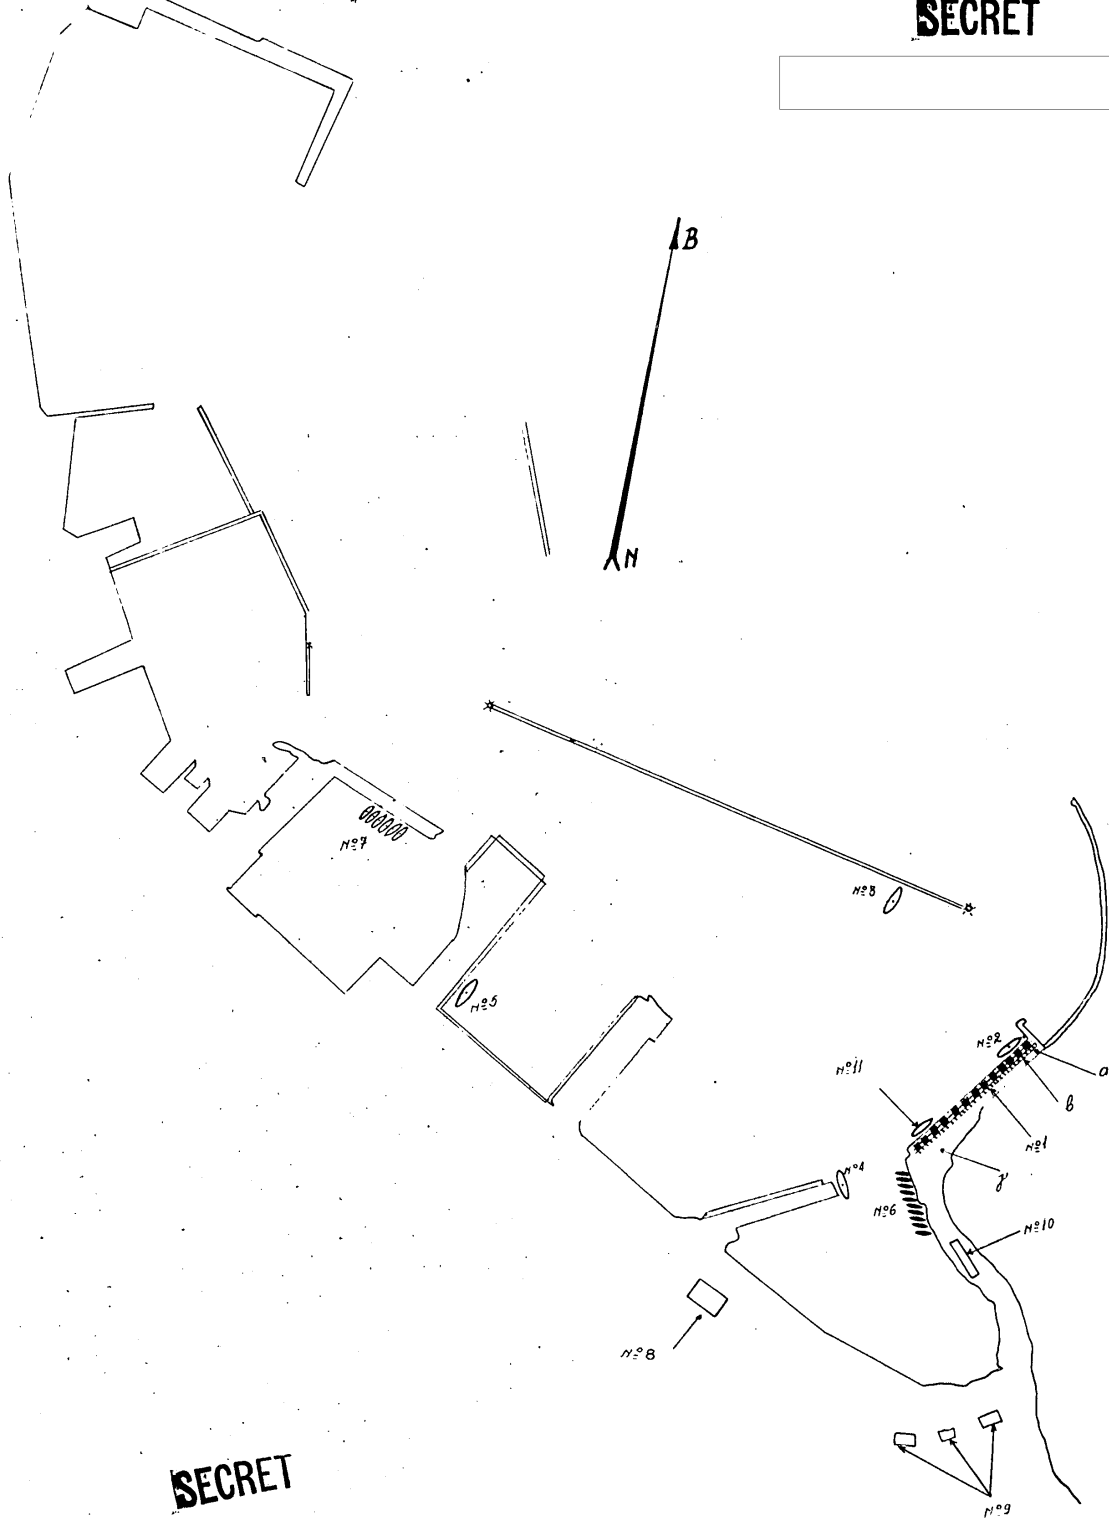
PORT OF

I. ORGANIZATION (See Drawing Attached)

I. A dock, on which [redacted] about twelve, new type cranes (expanding arm) with a lifting power of five tons [redacted]

a) Brand new crane of ten to fifteen tons lifting power, not yet being used.

II. Position, where the whaler "SLAVA" docked [redacted] accompanied by a flotilla of whale fishing boats.

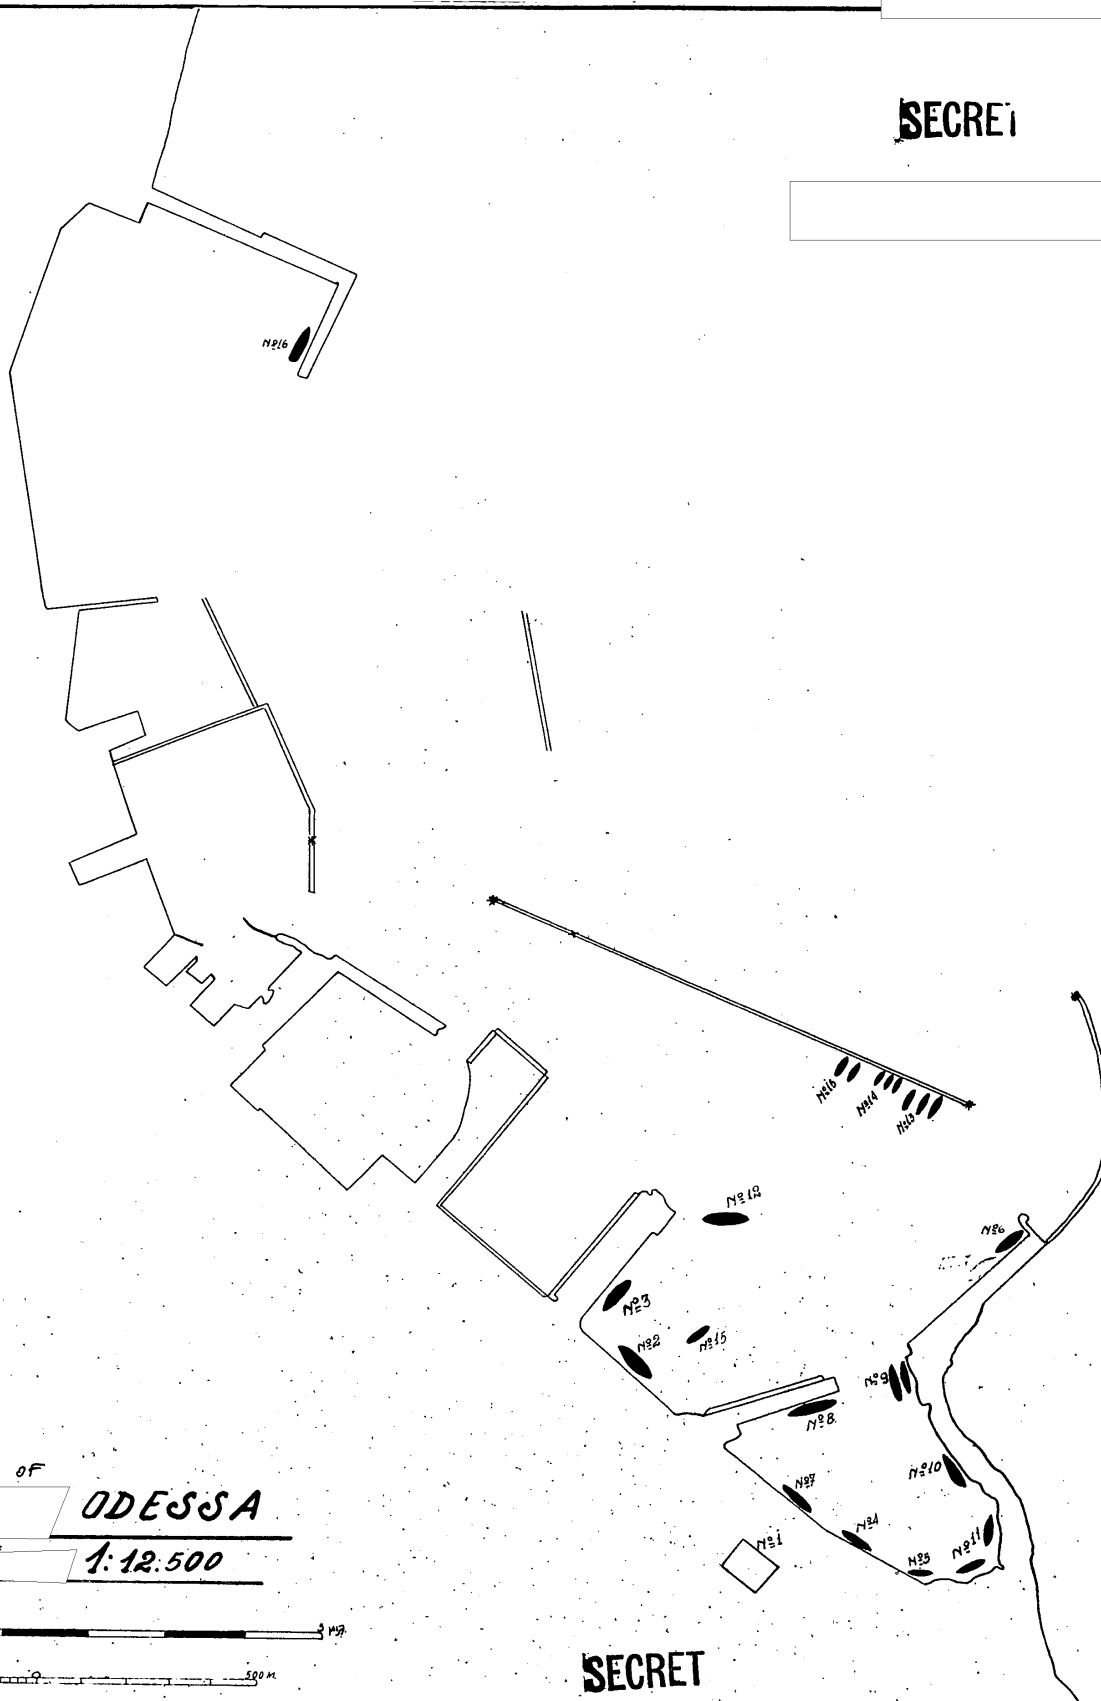
PORT OF
ODESSA
SCALE 1:12,500

I. ORGANIZATION (See attached plan).-

1. Two- or three-storey building with a concrete roof. On this there was observed RADAR with a solid antenna. This building is rather being used for housing various offices.

15. At this position there were observed two new freighters, evidently built in ODESSA. They were complete and the only things that were missing were the funnels and the masts. On one of them, ~~XX~~ between positions 10 and 11, they placed the funnel, the masts and the winches.

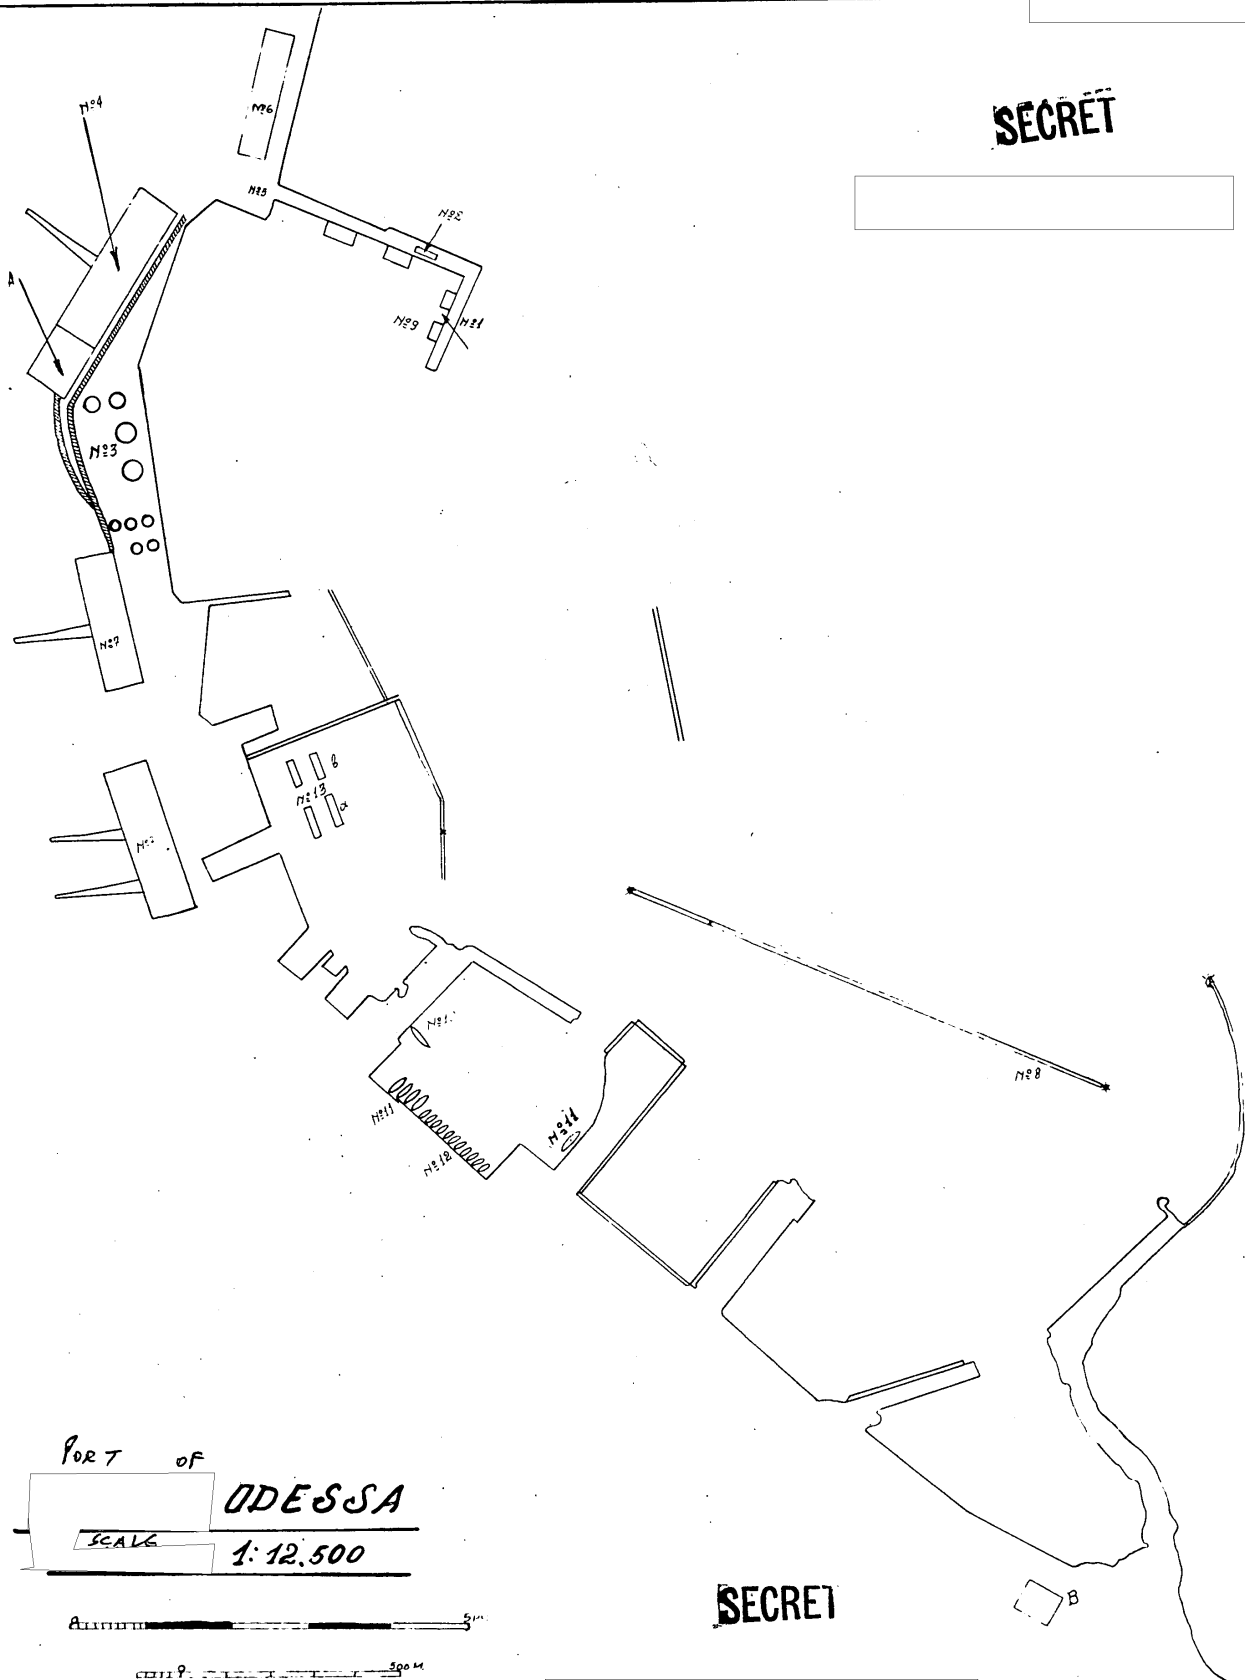
I. ORGANIZATION (See attached plan).--

On the piers there are three ~~XXXXXX~~ ^{2-foot}/diameter pipes, which end at the positions where the ships are being loaded in two other 8-inch diameter pipes.

13. At this position there were observed four cement dry-docks. The two larger a and b had each on them a Russian freighter.
